HCAL tile testing at BNL

Abhisek Sen, Megan Connors,
Andrey Sukanov, John Haggerty

Beam Test - April 2016

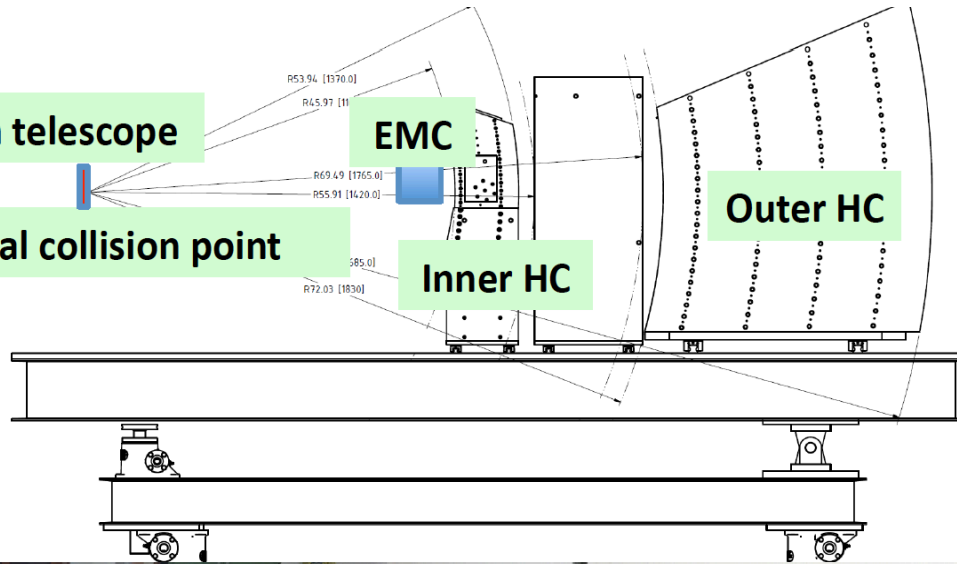
XY Si strip beam telescope

Virtual collision point

EMC

Inner HC

Outer HC

- Total tiles : 160
 - 80 InnerHcal
 - 80 OuterHcal
- Total 32 towers.

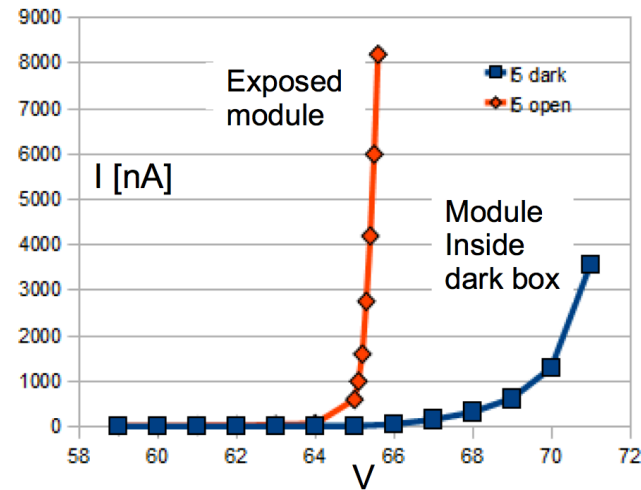
Light leakage

IV of the old HCal module,

There were a lot of light leakage with old holders.

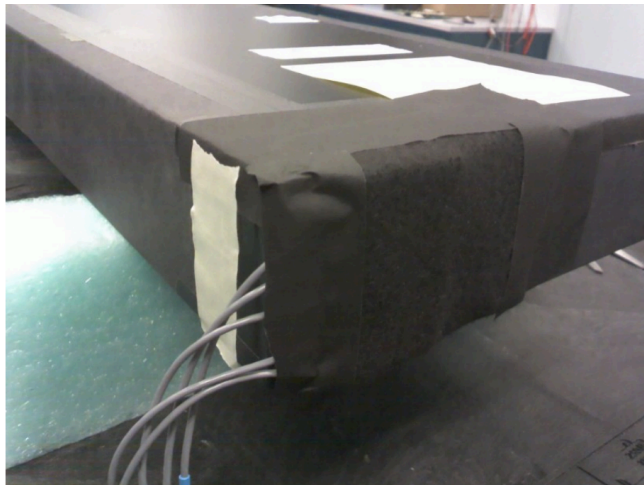
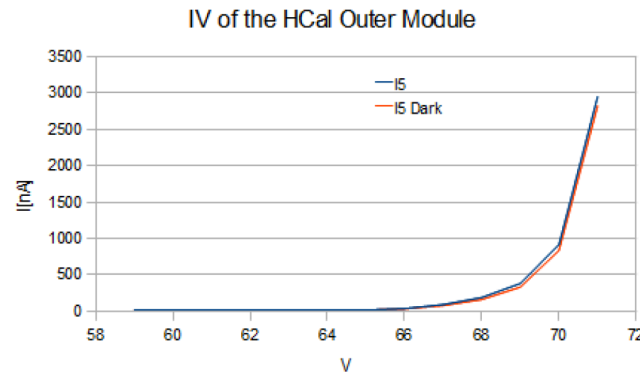
Red line: module in the dark box, dark room.
Blue line: module exposed to ambient light.

Almost no light leak.

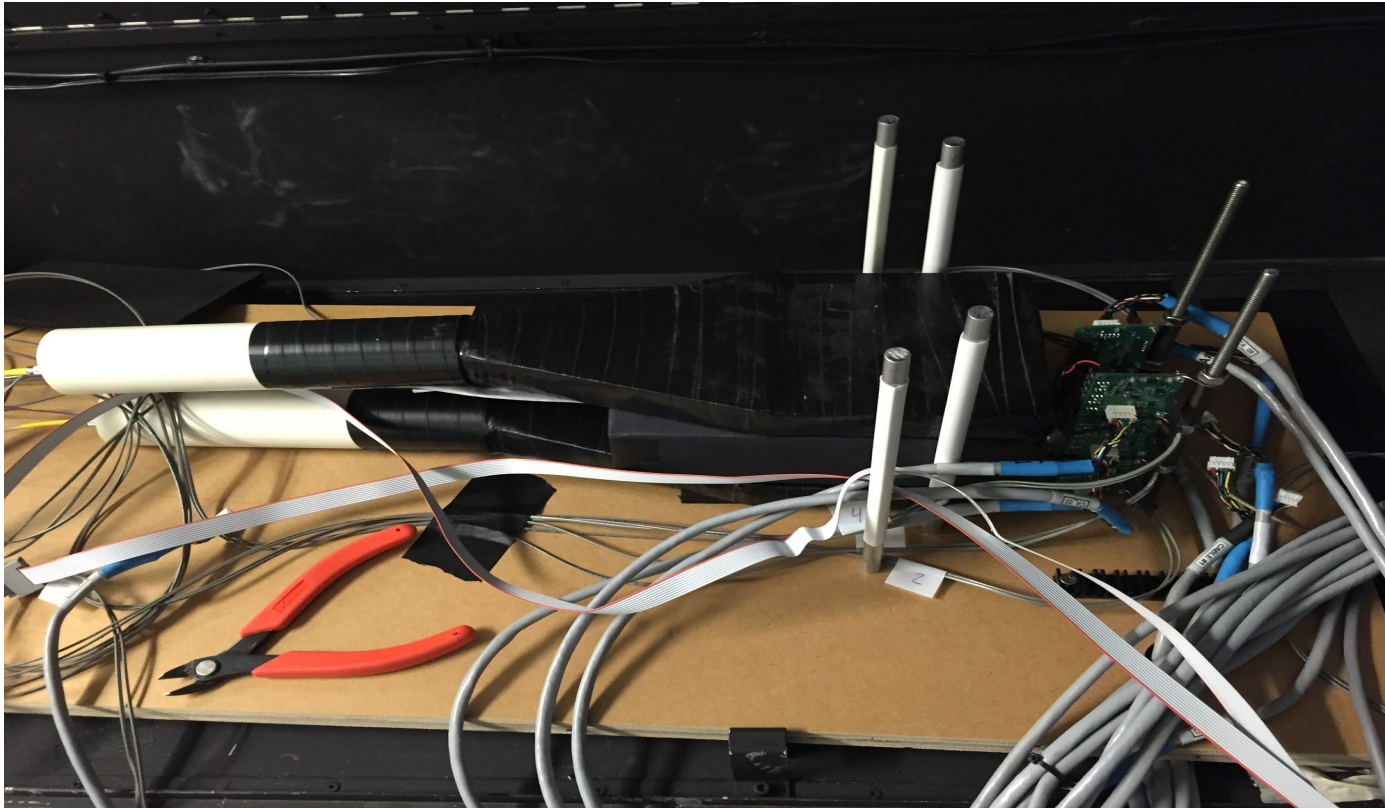
Cosmic setup with small tiles

5 tiles are connected to 5 separate preamps. All get same bias voltage from a distribution board.

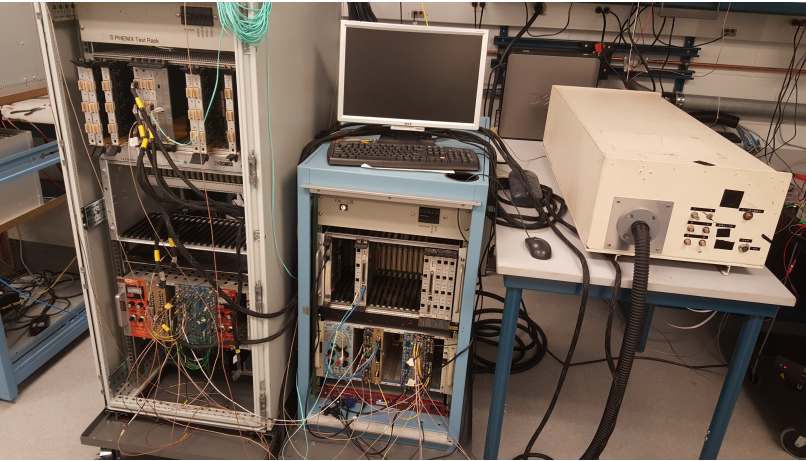
DAQ

HBD design

- 60 MHz sampling frequency.
- 14 bit ADC.
- 64 channels per board.
- Collects 24 samples.
- Each sample $\sim 16\text{ns}$, total $\sim 400\text{ns}$. (??)
- Trigger primitives based on 2×2 tower geometry.

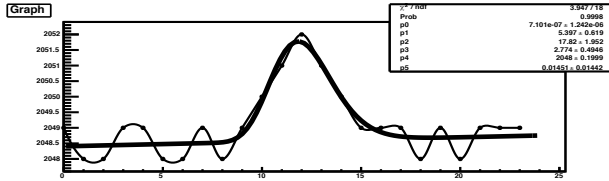
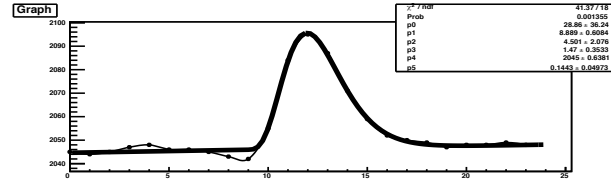
Tile 0

Cosmic signal in a tower

A convoluted power and exponential fit works better than Landau fit.

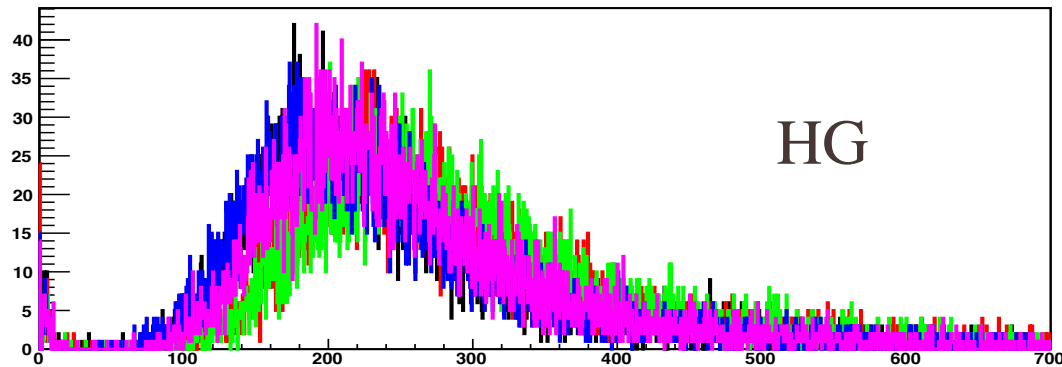
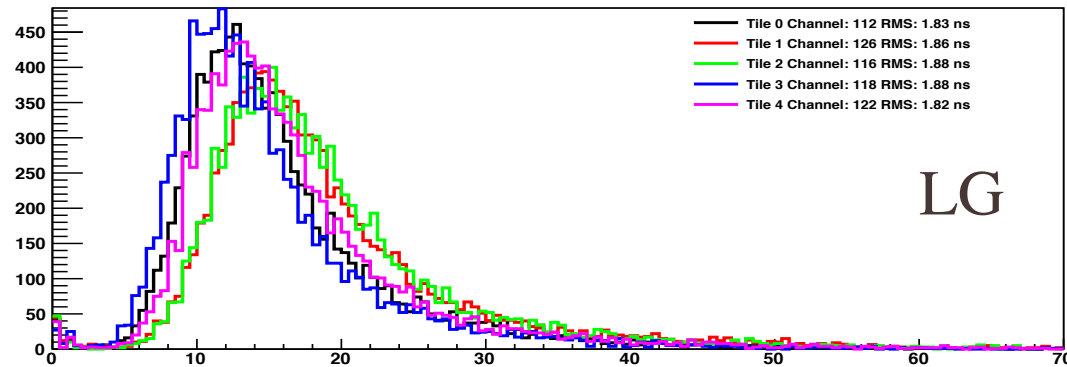
Cosmic signal from the small tiles

- Signal from all the tiles looks very consistent with each other.
- Consistent with earlier estimate from Edward, 30Pixels/MIP, 1Pixel~5mV for HG.

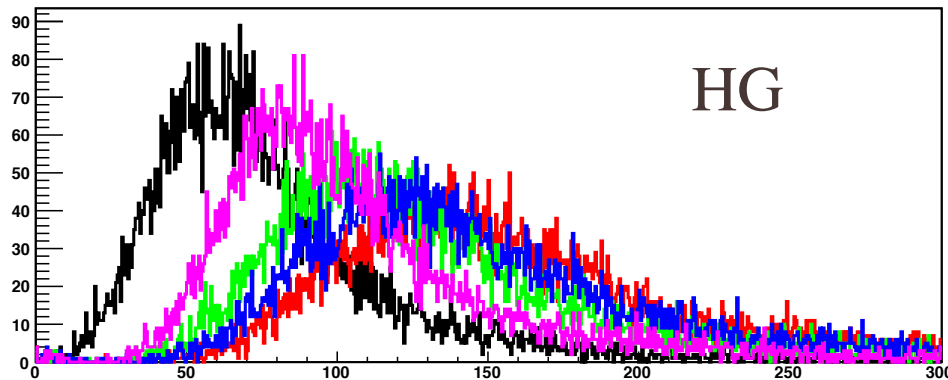
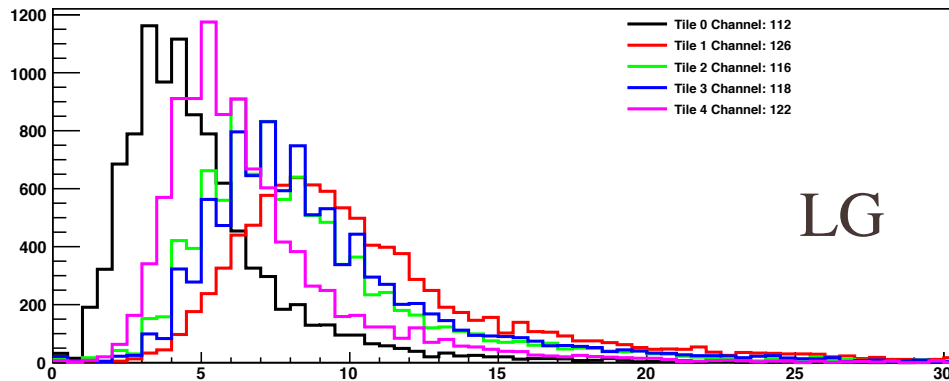
Cosmic signal with the big tiles

Significant variation of light output among the tiles.

- Are these tiles production or pre-production tiles?
 - We are not sure. Maybe pre-production tiles. Then the the light output variation is expected.
- Why the light output is smaller?
 - We don't know. That's a big mystery.

- ❖ Still haven't started with actual test beam tiles.
Waiting for some tiles get prepared.
- ❖ Light output is larger in the small tiles than long tiles.
- ❖ Large light output variation in the long tiles, which can be calibrated with LEDs in first pass.

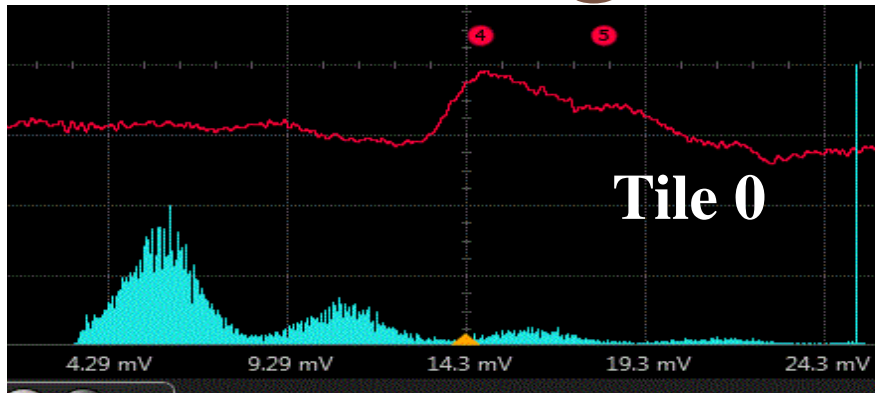
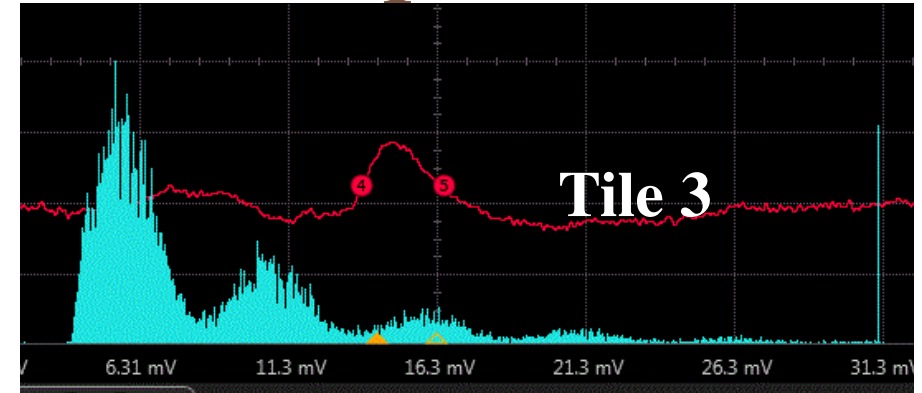
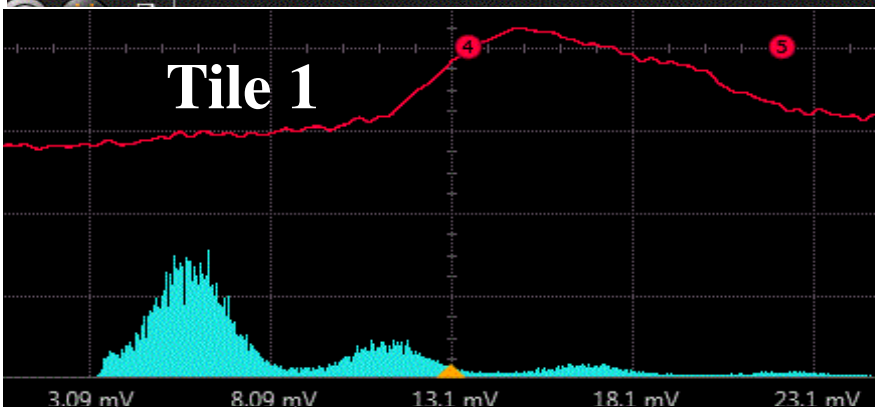
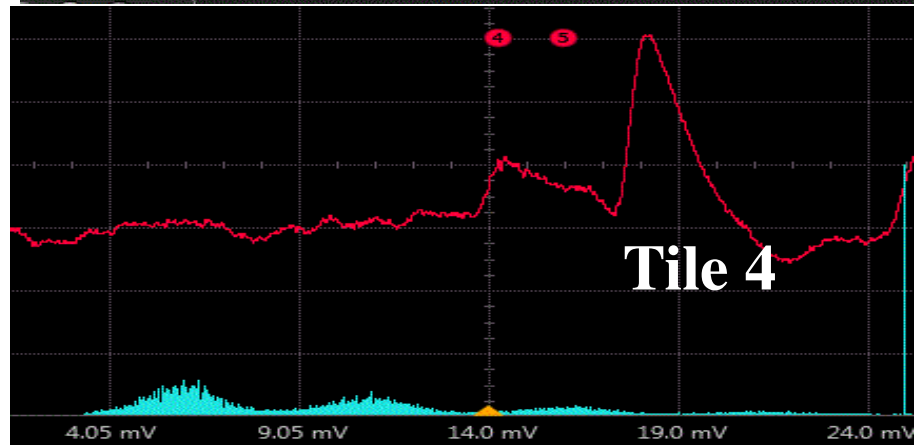
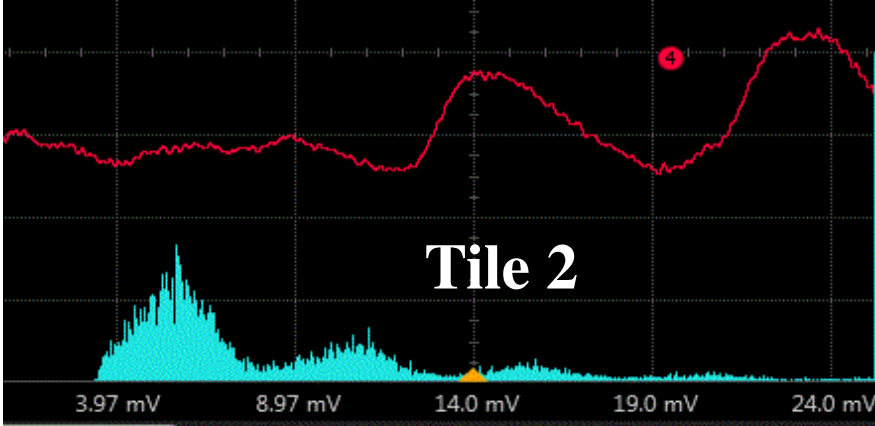
Investigation 1: Pixel peaks

All at 70V.

1 Pixel \sim 5mV for all the tiles.

Consistent with each other.

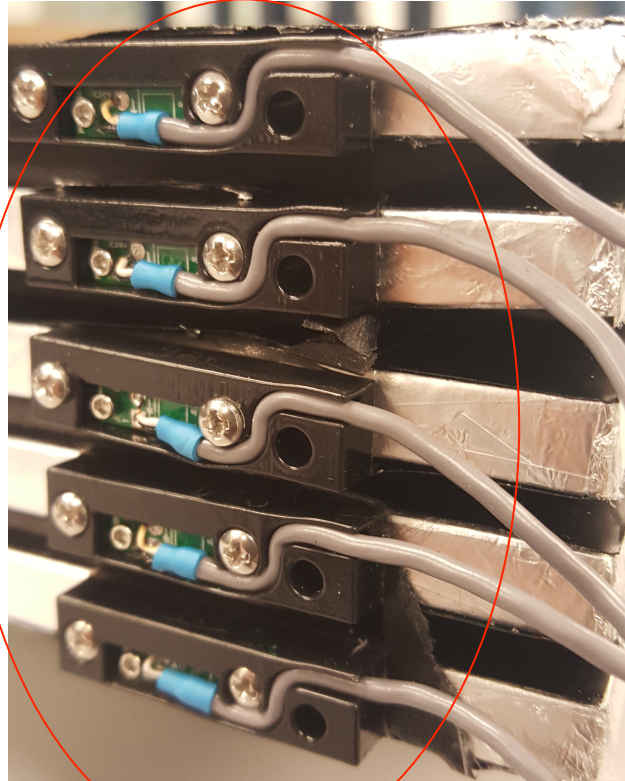
Alignment problem

Middle tile has bad alignment.
This is one culprit.

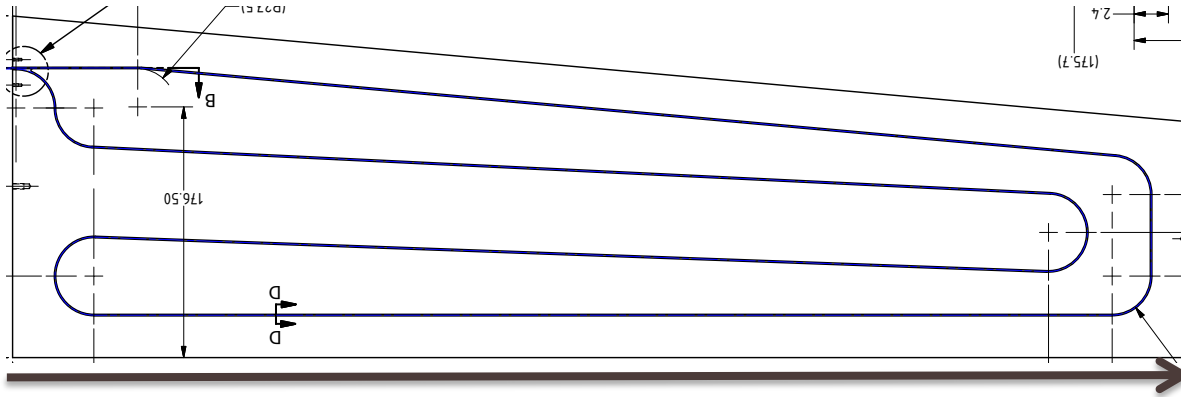
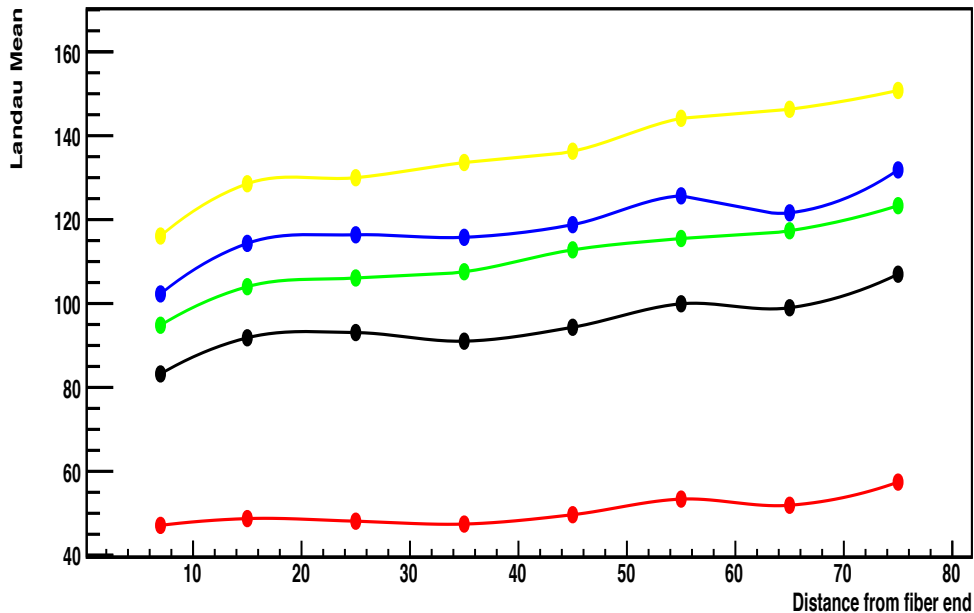
Investigation 3: Position

- Cosmic counters with active area 10.5cm x 12cm moved along the tiles.
- Very hard to get good position resolution.
- 1 hour run, ~3000 events/run.

Light output increases as you move away from the fiber end. Very surprising (?).

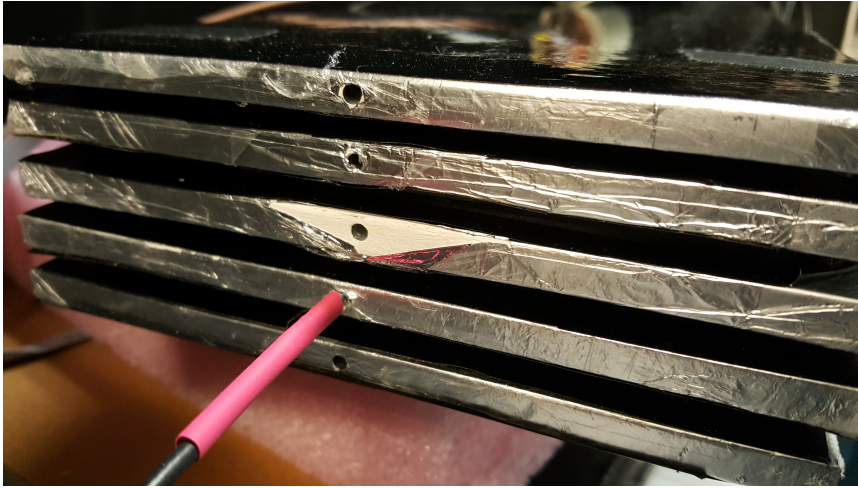
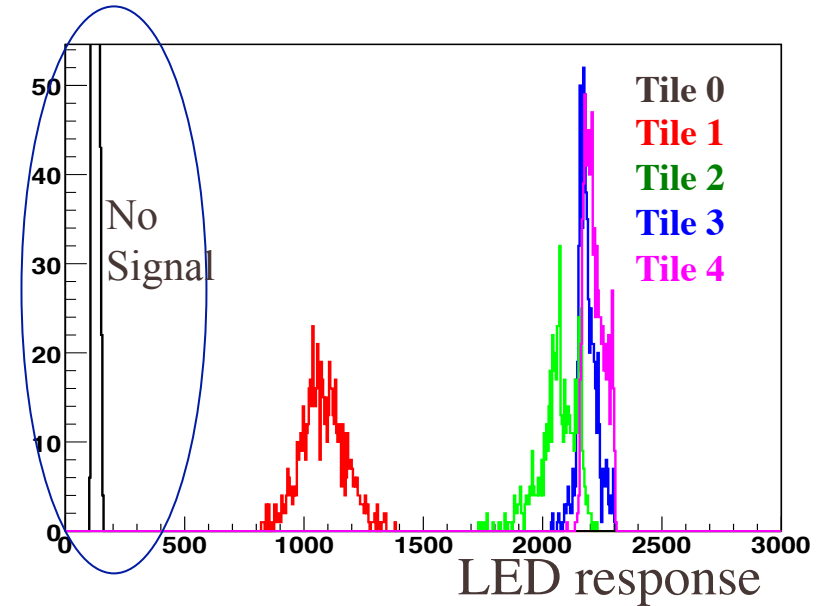
LED pulse

LED trigger

Tile response

LED response

- We set it up on Monday, looked into the data while I was in airport. Tile 0 somehow has failed.
- Plugged in at the hole at narrow end.
- LED signal is similar to the response from cosmic.

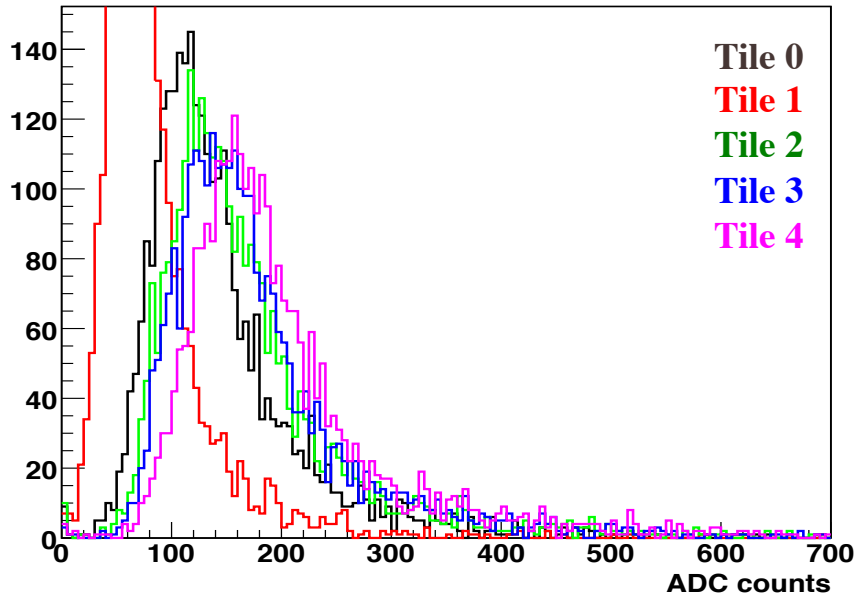
Before calibration

- Take a reference tile (Tile 4 in this case) and normalize the tower with respect to that tile.
- All signal looks very consistent with each other.
- This is a very good way to calibrate the tiles to some extent.
